**RECOMMENDATIONS FOR RISK
ASSESSMENTS OF ICE THROW AND
BLADE FAILURE IN ONTARIO**

Client	Canadian Wind Energy Association
Contact	David Timm
Document No	38079/OR/01
Classification	Client's Discretion
Date	31 May 2007

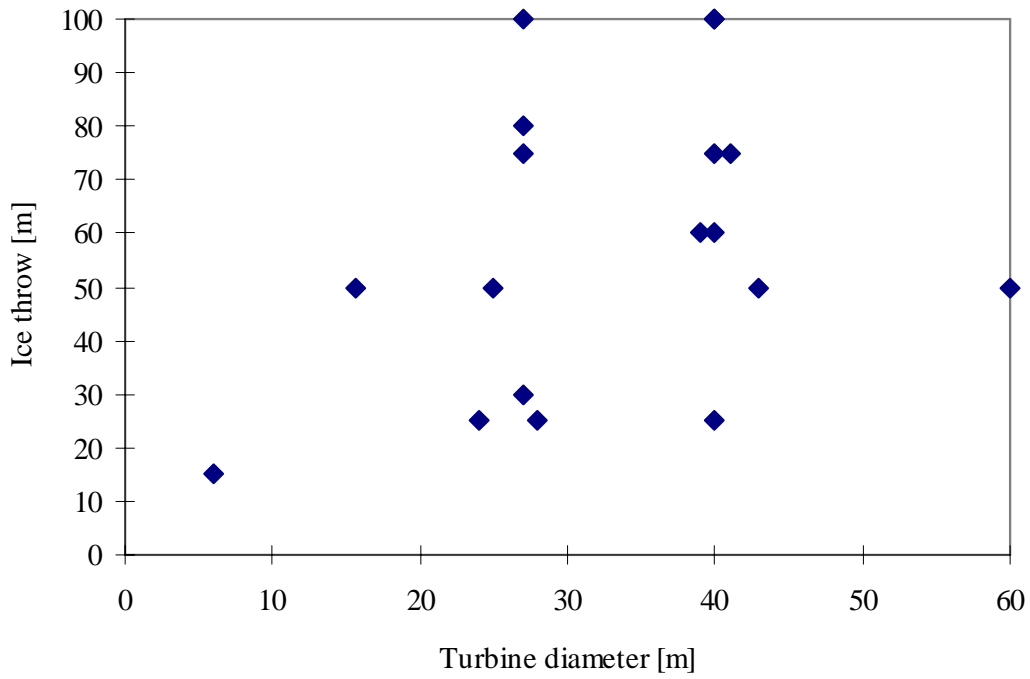
Figure 3.3 Recorded ice throw data (from [3.4])

In the EU WECO study [3.4], the observations of ice build-up on rotor blades and fragments shed from rotor blades were gathered from wind farms throughout Europe. The data gathered are presented in Figure 3.3, which shows that fragments typically land within 100 m of the wind turbine. Ice fragments with masses up to 1 kg were found although most were much smaller.

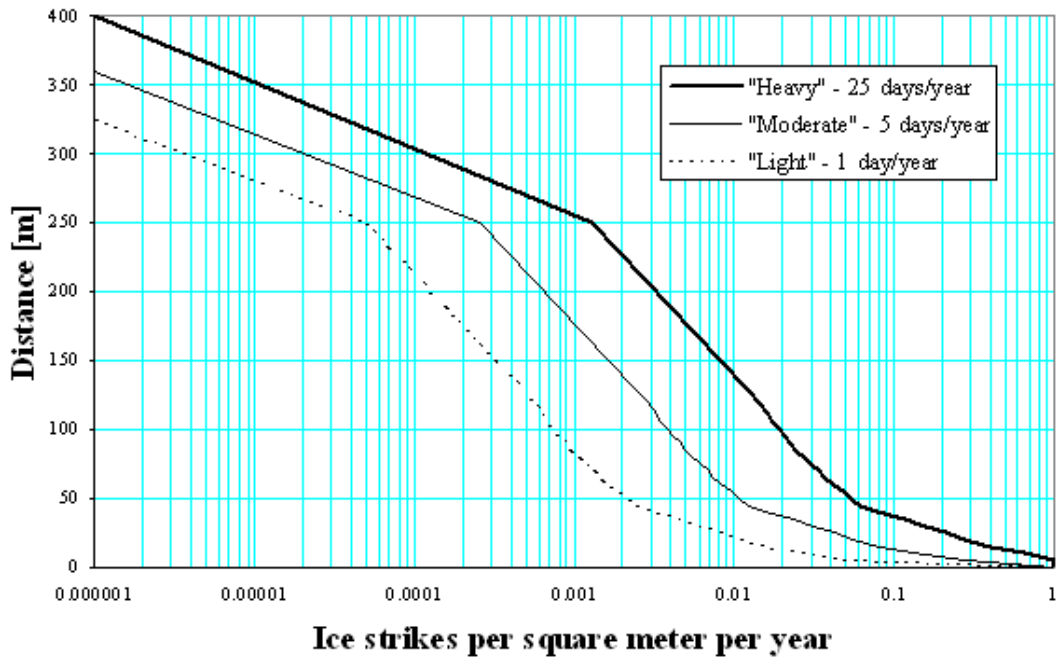
Figure 3.4 Recommended probability for ice fragment strikes in Ontario

When considering the results above and assuming three categories of icing conditions for this Ontario study, the chart in Figure 3.4 is proposed for use in risk assessment where detailed assessment is required. It will be noted that the critical distance of 220 m referred to above is significantly exceeded in the data presented in Figure 3.4. The curves provided for distances in excess of 250 m have been included on a pragmatic basis to add a level of conservatism at low probability values and are not based purely on the data presented in Figure 3.2.

- From Figure 3.4 for moderate icing conditions, the risk profile on the road can be plotted as presented in Figure 3.8.
- It is assumed in a rural setting that 100 vehicles traveling at 60 kilometer per hour will pass the turbine during the 5 days of icing events. From Figure 3.8, a vehicle would be exposed to hazard for a conservative 600 m segment of the road. Therefore, the fraction of time that a vehicle would be exposed to hazard is:

- From Figure 3.4 for moderate icing conditions, the risk profile for distances between 50 m and 300 m can be obtained.
- Given that the area between 300 m and 50 m is approximately 275,000 m² and calculating the distance weighted area under the 50 m to 300 m risk profile, the resulting IR probability for an individual with a plan area of 1 m² would be:

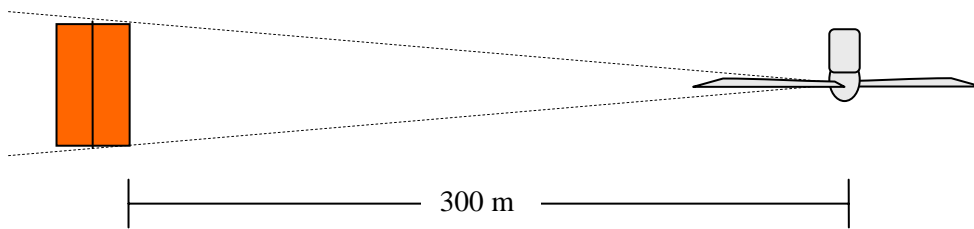
Figure 3.5 Scenario A – Fixed dwelling

For the purpose of the example calculations, the sites for all three scenarios are represented by the assumptions listed above. Moderate icing conditions (5 days per year) in flat open terrain have been assumed. The relevant distances for each scenario are presented in Figures 3.5 to 3.7. It is also assumed that there are no mitigation strategies as discussed Section 5 in place to prevent an ice throw event from occurring.

In this scenario, a 100 m² dwelling is situated at a distance of 300 m from a turbine, see Figure 3.5. Based on the general assumptions, the following calculation can be made:

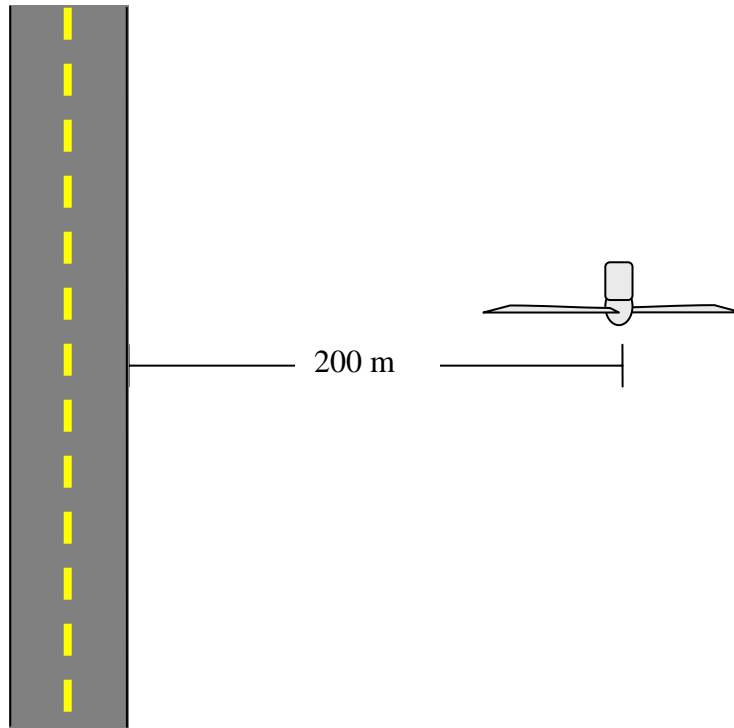
Figure 3.6 Scenario B – Road

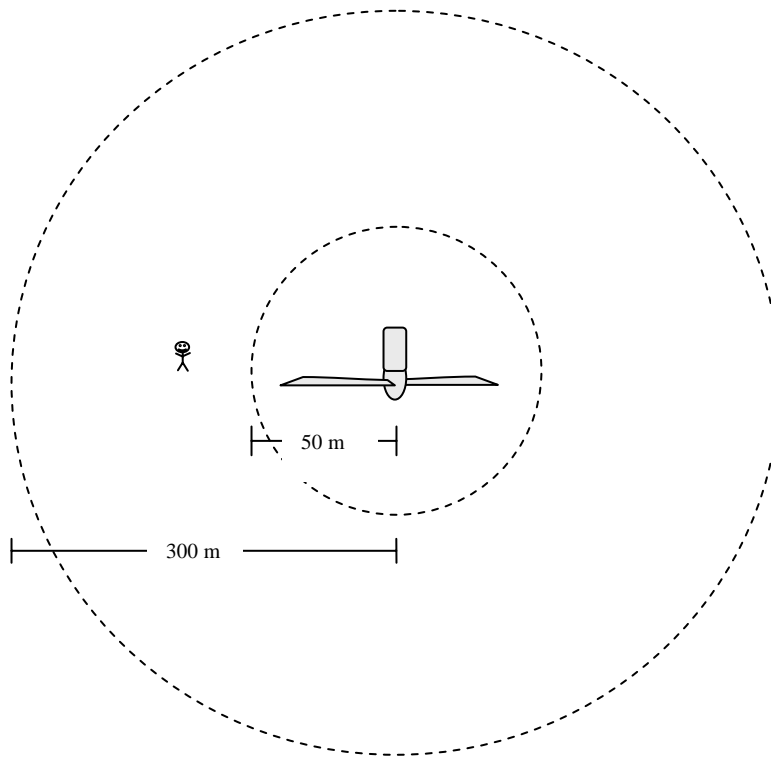
Figure 3.7 Scenario C – Individual
